Photographic Log

Facility Name:		Site Location:	Project No.:
Park Avenue Hotel Group Tennessee LLC aka Athens Lodge, Red Roof Inn		115 CR-247 Athens, TN	TN0028886
Photo No.	Date

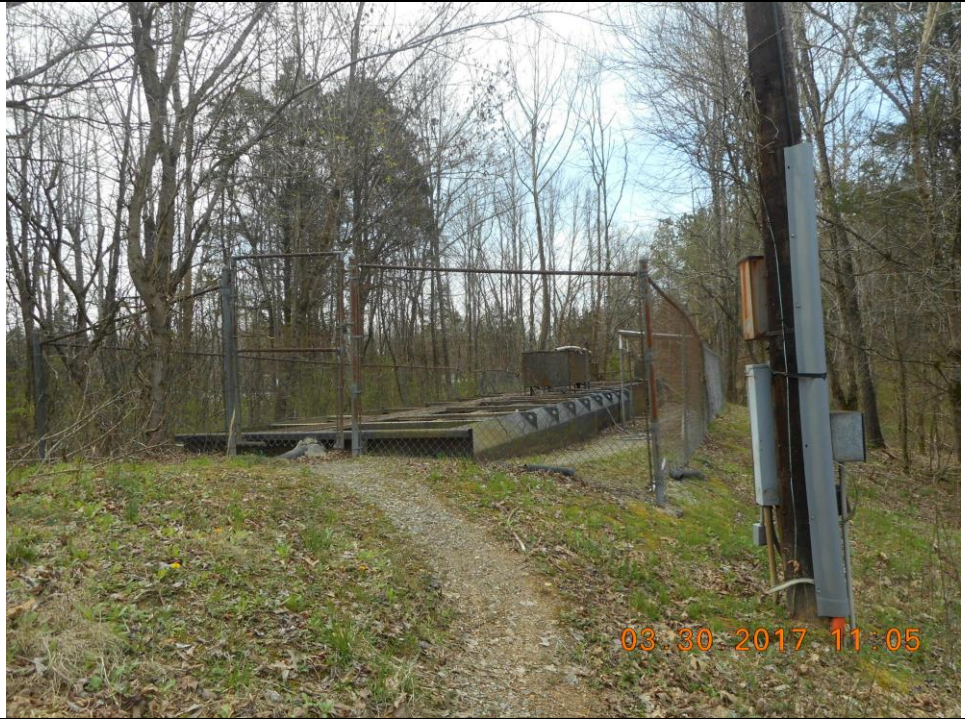
3	3-30-2017		
Description Wastewater treatment plant. Photo taken from termination of gravel access road facing south.

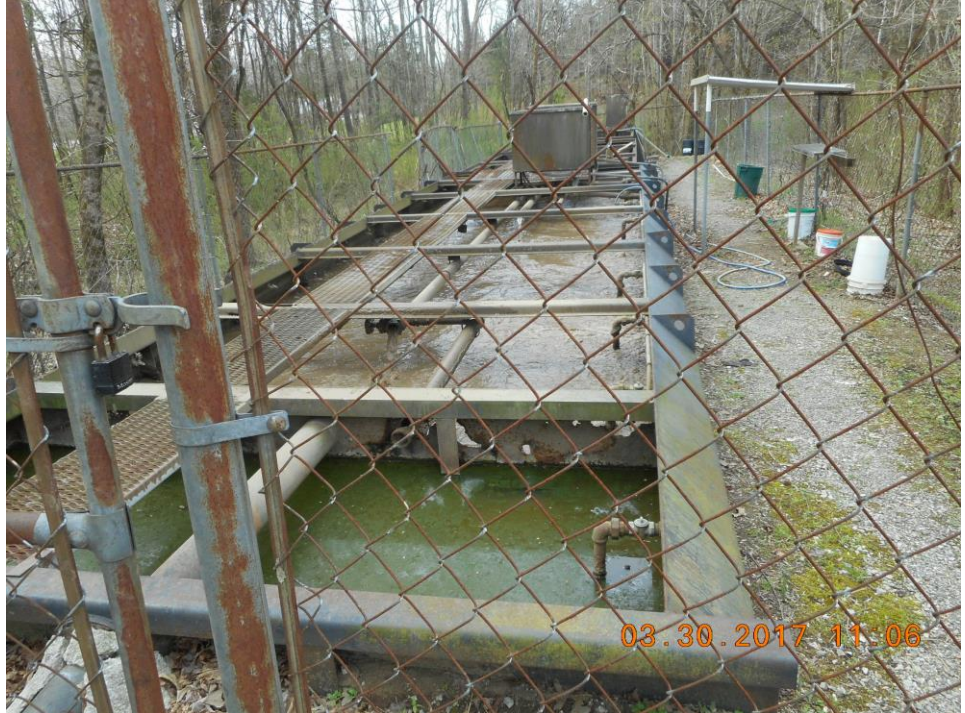
4	3-30-2017		
Description Wastewater treatment plant. Photo taken from outside the perimeter fence and gate facing south.

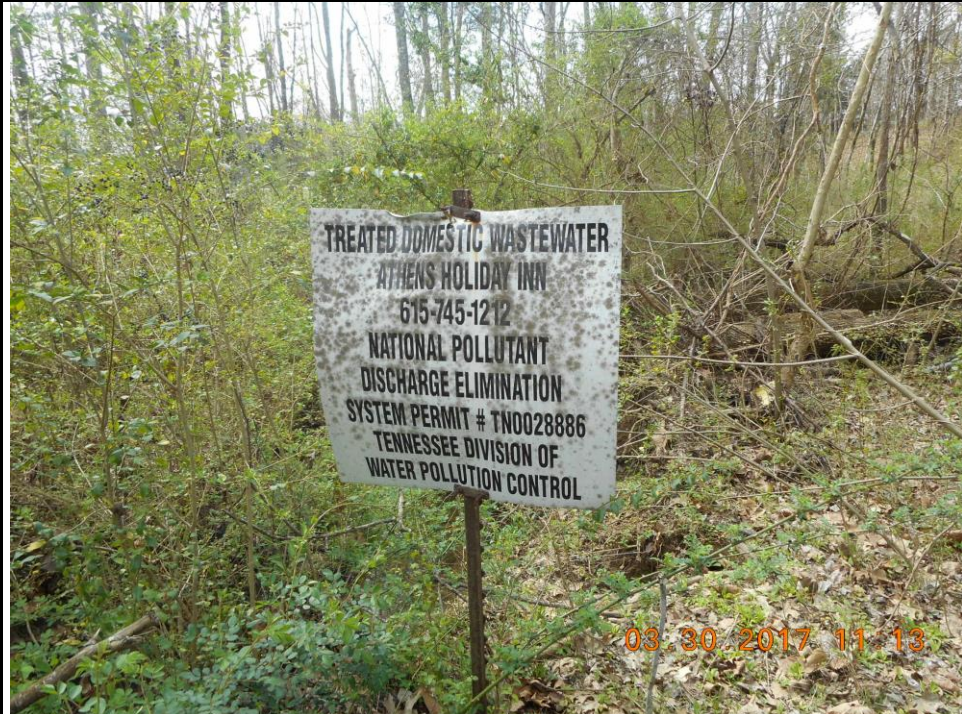
Facility Name: Park Avenue Hotel Group Tennessee LLC aka Athens Lodge, Red Roof Inn		Site Location: 115 CR-247 Athens, TN	Project No.: TN0028886
Photo No. 24	Date 3-30-2017

Description Outfall sign. Photo taken from north of the outfall sign facing west.
